THE STREAMBANK EROSION CONTROL  
EVALUATION AND DEMONSTRATION ACT OF 1974  
SECTION 32, PUBLIC LAW 93-251

Appendix G - Demonstration Projects on Other Streams, Nationwide

# FINAL REPORT TO CONGRESS

## APPENDIX G DEMONSTRATION PROJECTS ON OTHER STREAMS, NATIONWIDE

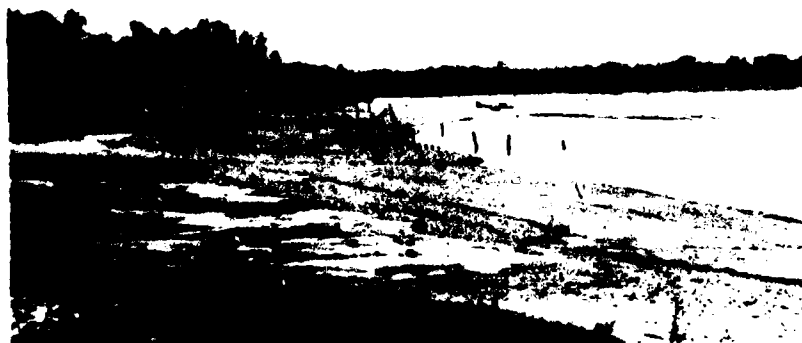
11. Rock Island District is now monitoring this project four times a year, including yearly surveys. Photo 10 is an example of the damage to the timber jetties. Some panels are bent or missing. Some panels were probably lifted off by ice action. Photo 11 illustrates some spalling on the surface of the erosion control mat, apparently the aftermath of a fisherman's campfire. The fabric covering of the erosion control mat has been cut by the jacks or cables in a few places. A break in the concrete erosion control mat was noted in April of 1981. The break is about 3 to 5 feet long. A knife blade could penetrate the break to about 1/2 inch, although the break is obviously the total depth of the mat. See photo 14. However, other than these minor problems, the fabric is in good condition. Photo 12 illustrates the damage to the steel jacks on the upstream end. The anchor cable securing these upstream jacks was broken during ice flow conditions.

12. Evaluation of Protection Performance. Flooding in the spring of 1979 resulted in some damage to timber jetties and to the steel jacks. This damage is shown in photos 10 and 12 as mentioned previously.

PHOTO 10. DAMAGED TIMBER JETTY AT STA 26+00. 7 MAY 1980.

13. Rehabilitation. Rock Island District personnel from Operations Division did repair work on the timber jetties during the summer of 1980. This work consisted of repairing or replacing damaged and broken wood panels and welding pipe extensions to some of the pipe piling. This work was completed at a cost of \$16,106.20. The broken cable previously mentioned was extended and anchored by Rock Island District personnel to a tree growing near the top of the riverbank. The cost of this repair work was \$400.

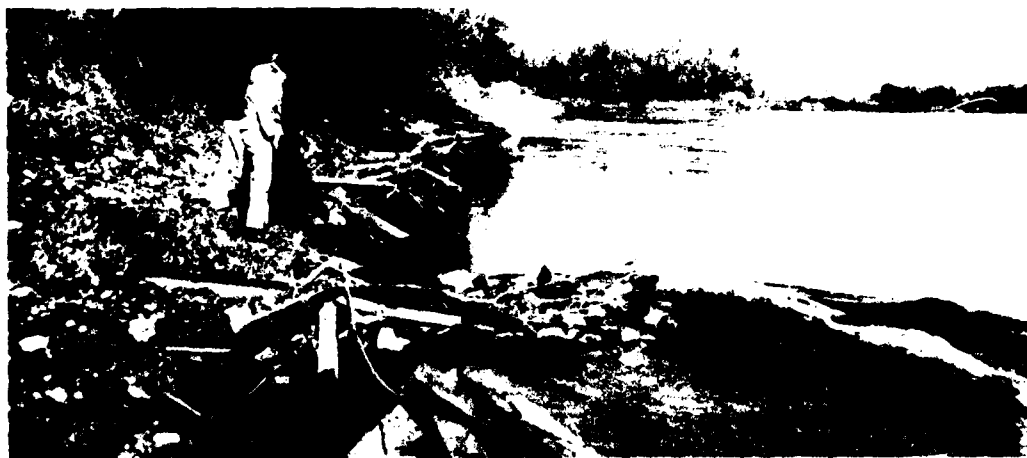
The erosion control mat and timber jetties protection has been effective in reducing additional bank erosion. The steel jacks, however, were not as effective as planned. This is probably due to two conditions. One, water and ensuing debris are moving too fast when they strike the steel

PHOTO 12. STA 6+00 LOOKING UPSTREAM AT DAMAGED STEEL JACKS.  
14 NOVEMBER 1979.

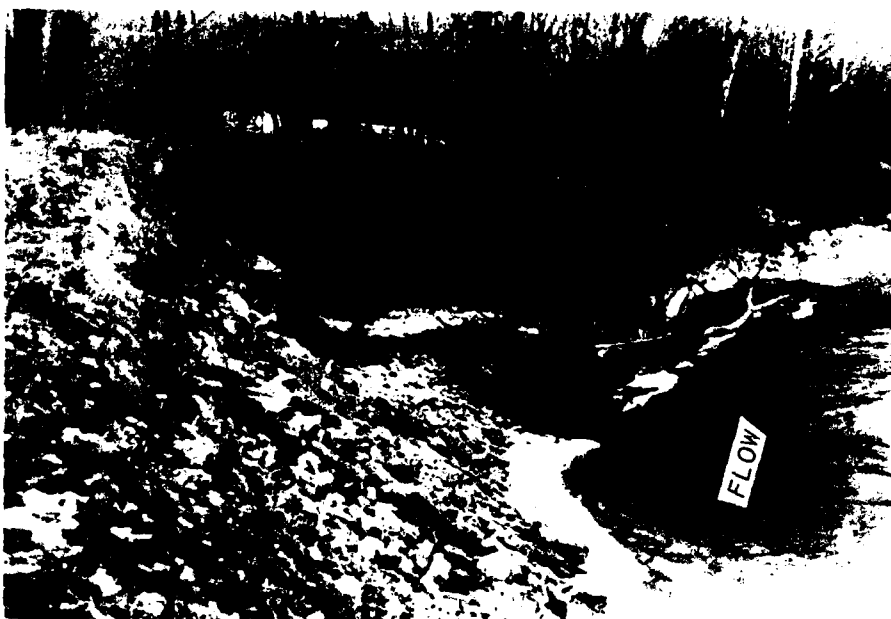
PHOTO NO. 5. 5 Jan. 81. Erosion downstream end of project. Repair of this transition to natural section will be required.

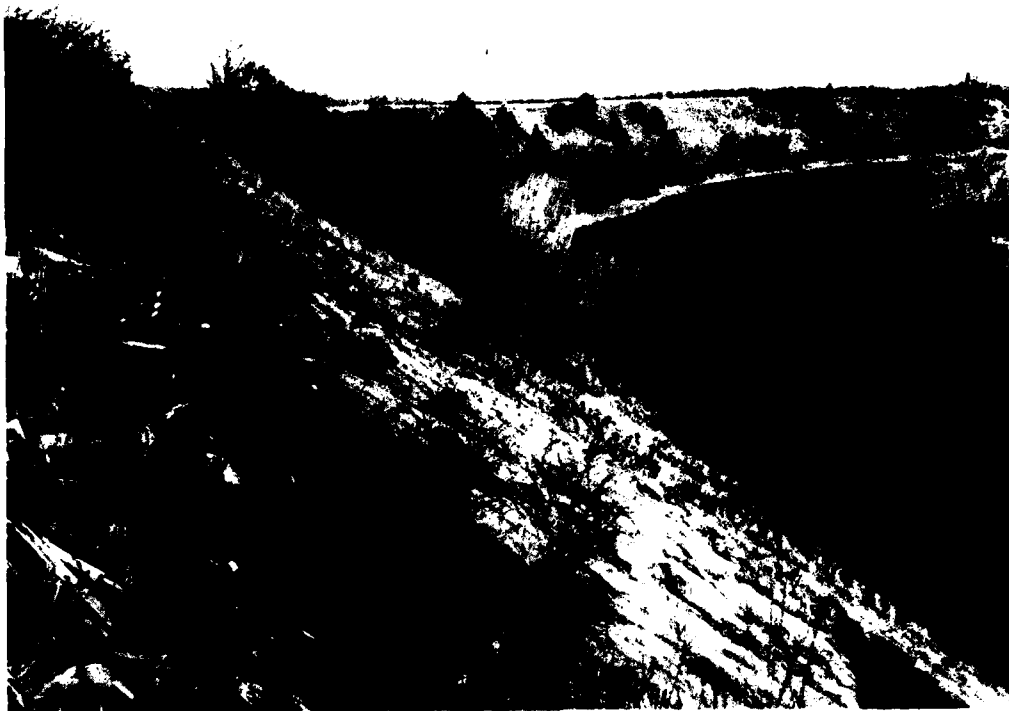
PHOTO 1. SITE NO. 3 - HIGH, LOOKING UPSTREAM, BANK  
ABOUT 100 FEET HIGH, 30 OCTOBER 1980.

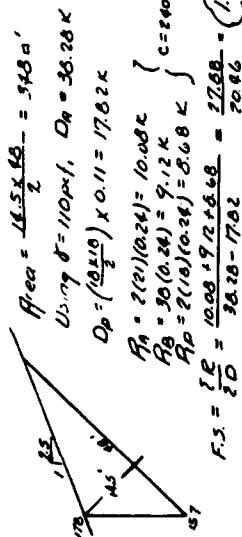
Using  $c = 200 \text{ pcf}$ ,  $F.S. = 1.13$   
 Using  $\delta = 100 \text{ pcf}$ ,  $F.S. = 1.50$   
 Using  $\delta = 100 \text{ pcf}$  &  $c = 200 \text{ pcf}$ ,  $F.S. = 1.25$

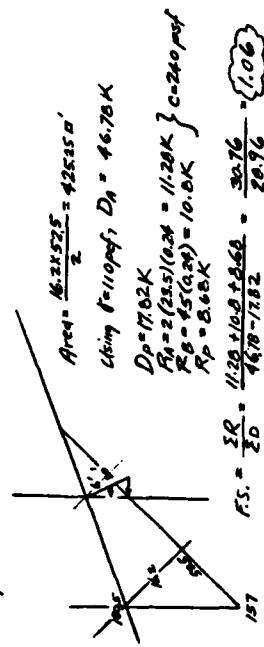
$$F.S. = \frac{11.28 + 10.8 + 8.00}{46.78 - 17.02} = \frac{30.08}{29.76} = 1.06$$

$$\text{Using } C = 200 \text{ pcf, } F.S. = 0.88$$
